VALLEY FORGE LOAD INDICATING SOLUTION PETRO-CHEM INDUSTRY

LOCATION: Theodore, Alabama, USA

SPECIFIC APPLICATION: Gasketed Pipe Flange

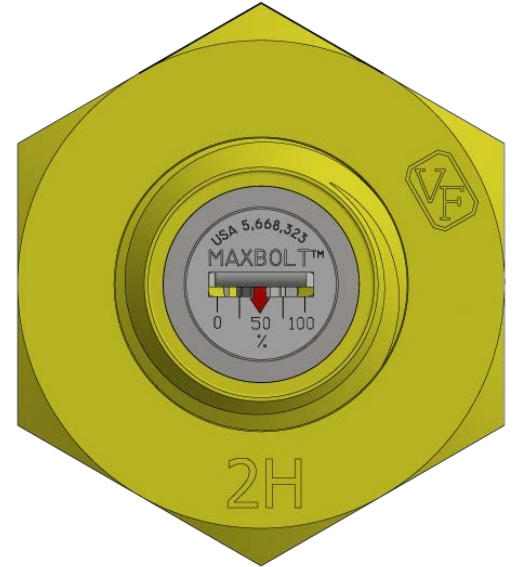
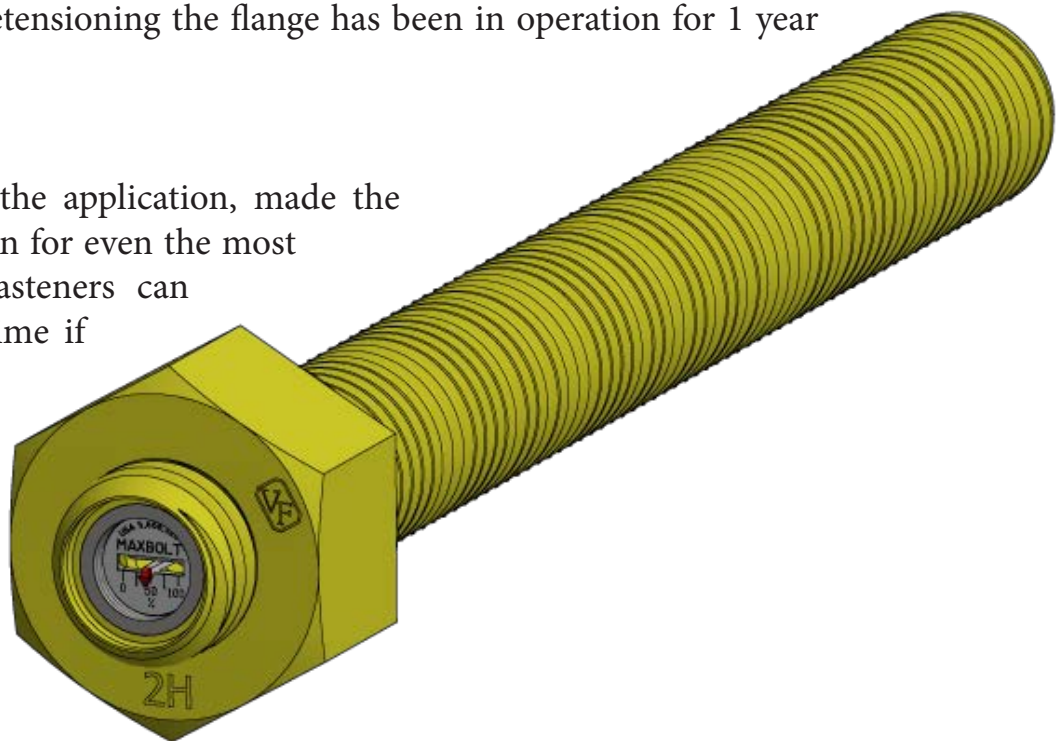
Recurring leaks from a problem flange. The flange was frequently repaired, only to begin leaking again within 2 weeks. Fugitive Emissions from recurring flange leaks.

In October of 2016 the Maxbolts were installed. The unit was placed into service for 48 hours then shutdown for inspection. The Maxbolts displayed the residual clamp load which was dramatically lower than the installed load. The studs were then retightened to the original tension.

VALLEY FORGE SOLUTION: 3/4-10 x 7-1/2" Maxbolt™ B7 Studs

After proper installation and retensioning the flange has been in operation for 1 year with no recurrence of leakage.
