# VALLEY FORGE LOAD INDICATING SOLUTION OIL & GAS INDUSTRY

**LOCATION:** New York, USA

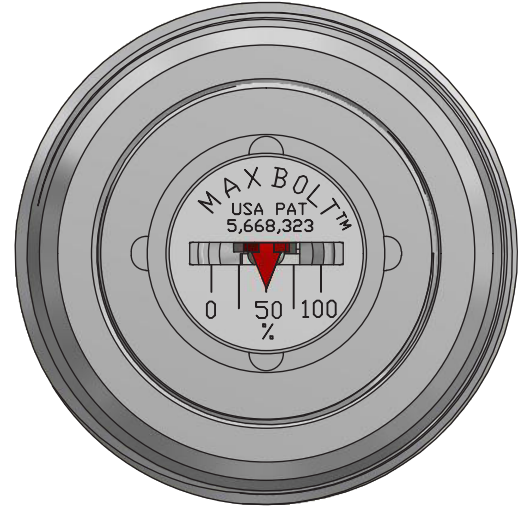
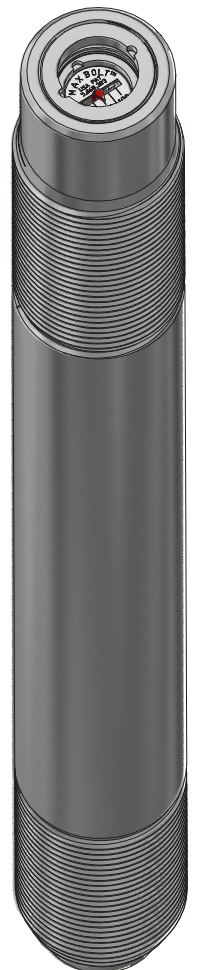
This application is for case studs in a split case compressor. Bottom B of the case has studs threaded into it around the edge of the casting. Top A is lowered onto the case (and protruding studs), then nuts are used to tighten the studs.

Maxbolt™ no-standoff load indicating studs were used in place of commodity class double ended studs.

Installation of the studs was faster with the ability to ensure proper load on the joint. By using the Maxbolt™ load indicating studs, the assembly team was ensured the proper load on the assembly and had zero failures when they conducted their hydro testing for leaks. Tightening was achieved by hydraulic wrench.
