VALLEY FORGE LOAD INDICATING SOLUTION STEEL INDUSTRY

SPECIFIC APPLICATION: Slew ring bearing for an Electric arc furnace (EAF) roof gantry.

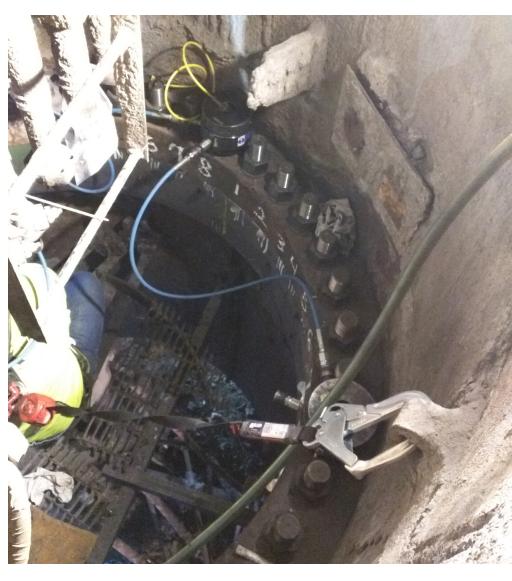
Valley Forge's solution was the use of No-Standoff SPC4[™] Load Indicating double end studs, along with a SPC4-500A mechanical load reader for routine load checks.

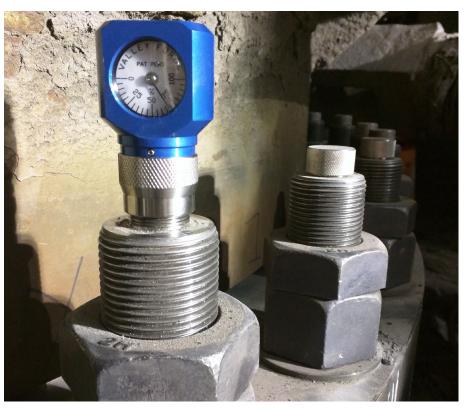
only low, but also exhibited a high degree of variation. This was most notable on the inner studs, which were tensioned after the gantry structure had been lowered onto the bearing. A final pass using a single tensioner in conjunction with an SPC4™ 404A electronic load reader, was completed to guarantee each stud was tensioned to the desired load.
